VELA UNIFORM PROJECT **SHOAL**

TEST OF DRIBBLE-TYPE STRUCTURES

Holmes & Narver, Inc.

January 1964

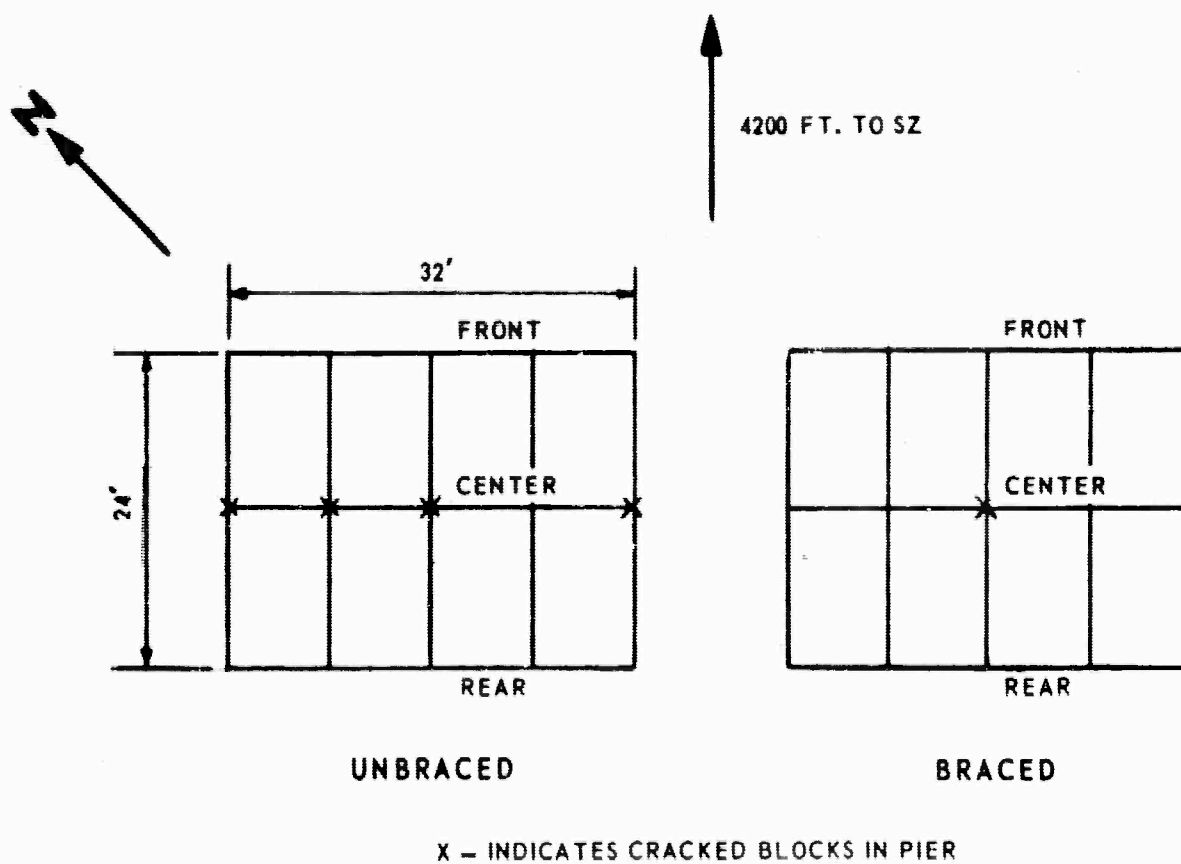
Figure 11 Postshot Station A, Foundation Plan

At the Station A unbraced building damage was confined to the concrete blocks in the center row of piers. See Figure 11. Four piers in that row were cracked (all but the inner-right pier, facing SZ), and all three of the blocks were cracked in the center and center-left piers; see Figure 16. In the extreme right and extreme left piers of the center row, only the upper blocks were cracked. See Figure 17.

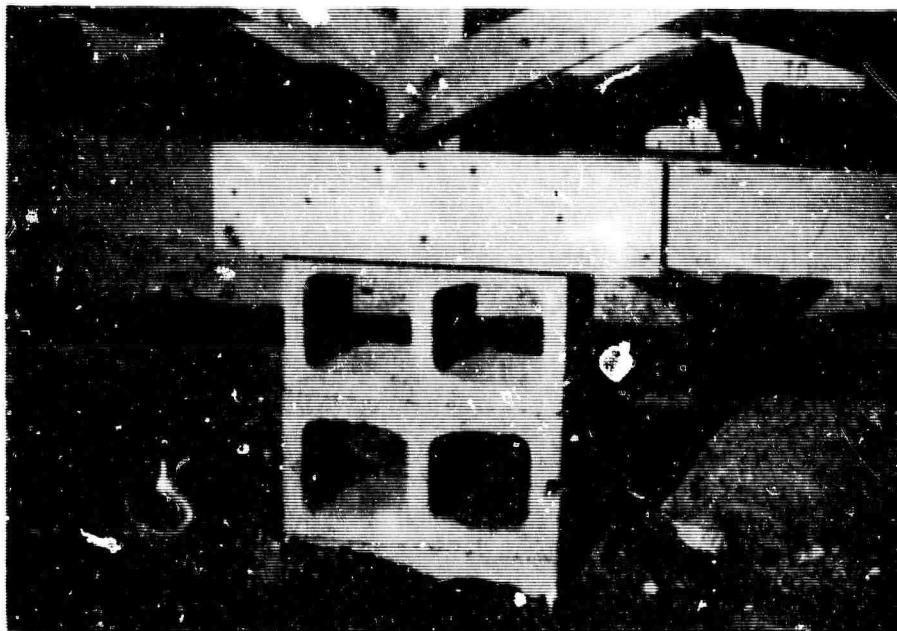
Figure 14 Postshot Station A Unbraced,
Rear-Center Pier

The pier damage appears to have resulted primarily from vertical motion. In the unbraced buildings, the maximum computed static pier reaction (on the two inboard piers of the center row) was 2760 lbs., causing a unit stress of about 100 psi in the vertical "webs" of the blocks. During the motion, this stress could have been momentarily increased, at Station A, to $100 + 1.3(100) = 230$ psi, which is well below the compressive strength of any structural concrete. However, most of the damage is seen to have occurred in the horizontal flanges of the blocks in a manner indicating a shear failure, see Figures 14, 17, and 21.

Further inspection of Figures 14, 17 and 21 shows that the damage is without exception either on one side or the other of the center webs of the pier blocks, but not on both sides. This circumstance indicates uneven bearing of the sill timber on the pier, which is probably to be expected whenever the sill timber is not continuous over a pier. If we assume that the sill is bearing on only half of the top block, the shear stress on flange sections near the webs was over 300 psi, which could result in failure. In fact, a condition of line bearing of the end of a sill timber on the pier might be expected, particularly when the structure slams back down on the pier after the

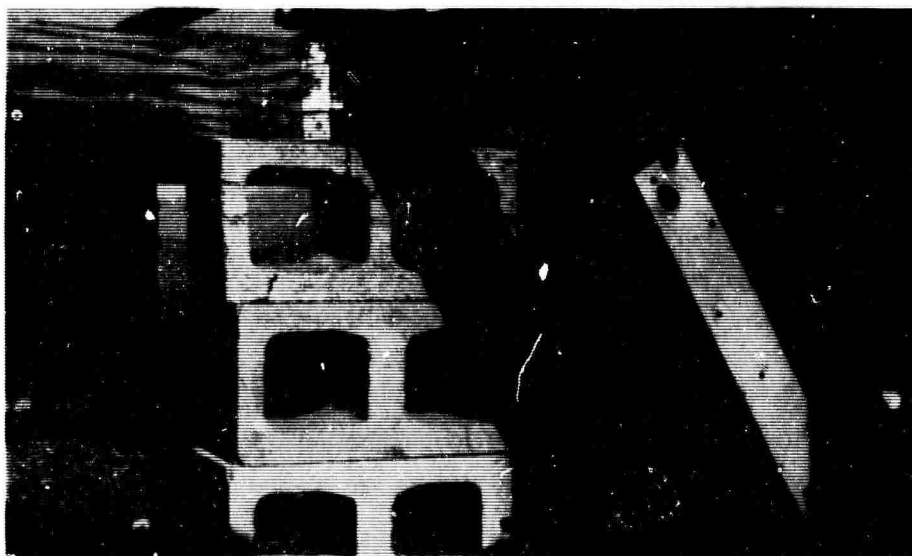
Figure 21 Postshot Station A Braced,
Center-Center Pier

At Station A in the braced building, the only damage was to the center concrete block pier in the center row. See Figure 21. Only the top block in the pier was cracked.

No meaningful significance is attached to the slight movement of some of the blocks relative to each other, as seen in Figure 21. Such motion is to be expected during the free-fall phase of the motions.

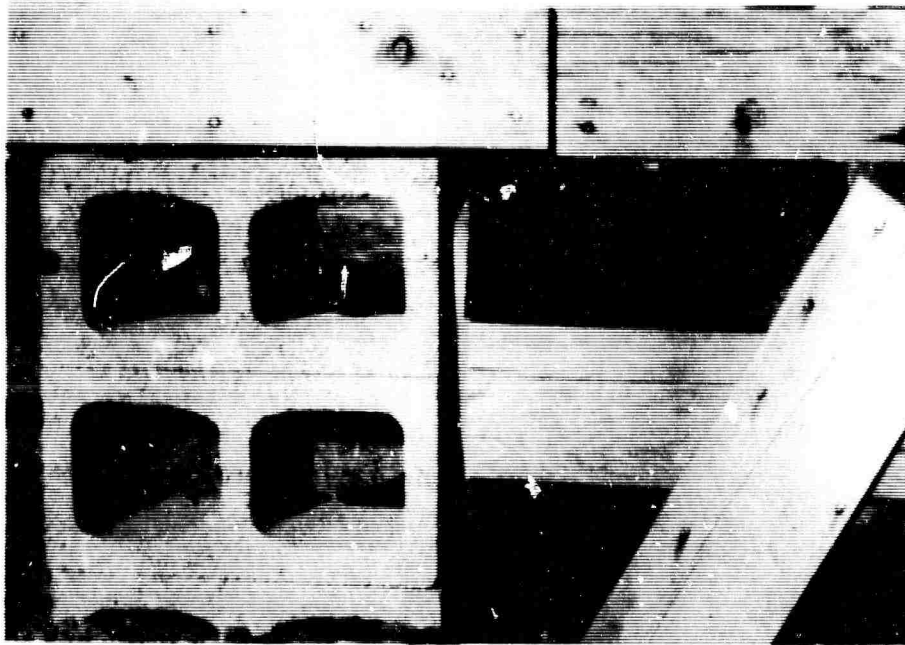
Figure 22 Postshot Station A Braced,
Rear-Center Pier

At all the piers but two (center and center-left piers of center row) the weight was mostly on the timber crib, as evidenced by daylight between the 4x6 sill timbers and the top block of the pier, see Figure 22. The top blocks of both extreme right piers of center row and row toward SZ could be moved by hand, indicating all of the weight at those piers was being supported by the cribs. There was no apparent motion of the frame relative to the pier tops, and no distress in any of the wood cribs.
